*TECH TIDBITS, vol. 16*

## Incompatible Materials Cause Downtime

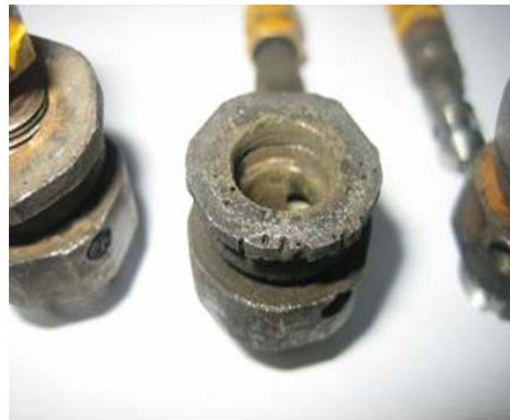
Once the BOP was on the surface, the system was bled down and repairs commenced. The failed valve was found to be in a severely corroded state, as were six other charge valves on the LMRP accumulator circuit and one charge valve on the BOP circuit (Figure 1). Three of the valves removed from the LMRP accumulators were in such a deteriorated state that after removal they literally fell apart.

**Figure 1:** Schrader valve showing severe corrosion.

The valves in question were made of 303 stainless steel (SS) and were found to contain 410 SS retaining pins. Both of these steel types are unsuitable for subsea applications, and are also prone to galvanic corrosion when placed in contact with each other in the presence of an electrolyte, such as seawater or control fluid. In this case, the 410 SS is more anodic and will preferentially corrode. In fact, the rig suffered a near-miss accident during an attempt to check the pre-charge on a bottle when a retaining pin failed and ejected the stem and trash cover. Considering that even 303 SS has a very short incubation time when exposed to a chloride environment, both of these materials should be avoided for subsea applications. This prompted the contractor to replace all 60 stack nitrogen charge valves.

It was decided to change the charge valves to a 316 SS design (ordered from the same manufacturer) that offered substantially better corrosion resistance in a subsea environment. However, the change-out proved unsatisfactory as the valves suffered a 50% failure rate when pre-charging 20 accumulators to 4000 psi (Figure 2). An investigation revealed that the valve design utilized a concave metal surface on the internal stem to seal against a polymer seat. It was discovered from the manufacturer that the maximum allowable make-up torque on the swivel nut was only 5 ft-lbs; more than this and the stem could easily tear or puncture the polymer seat and prevent the valve from achieving a seal. Such a valve design was deemed unfit for use on subsea accumulators. This problem could easily have been avoided if the contractor had been more specific when discussing application requirements with the

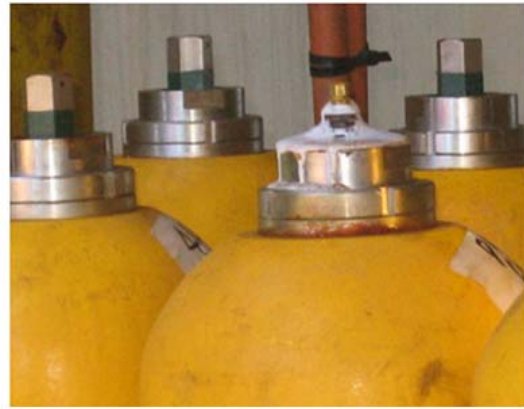
valve manufacturer. The application of the actual valve was not discussed, only that the valve needed to be 316 SS. The valve manufacturer sent what was available in 316 SS, a polymer sealing valve intended to provide a robust seal in a high vibratory environment.

**Figure 2.** Leaking Charge Valve.

As excessive vibration was not an issue with the rig, it was decided to again change out the valves. Due to time constraints, the contractor decided that reinstalling 303 SS valves, similar to those used in the initial accumulator application, was an acceptable risk, and had all 60 accumulator valves replaced. This type of valve, though 303 SS, used a metal to metal stem seal design instead of an elastomeric one, allowing for a greater tolerance for make-up torque. Future plans include “hybrid” valves that offer a metal-to-metal stem seal and are made entirely of 316 SS.
