TECH TIDBITS, vol. 18

Should You Clean Your New Equipment?

A newbuild rig was having problems with corrosion and debris in the conduit lines, the auxiliary lines, the risers, the blind shear and casing, and the test stump.

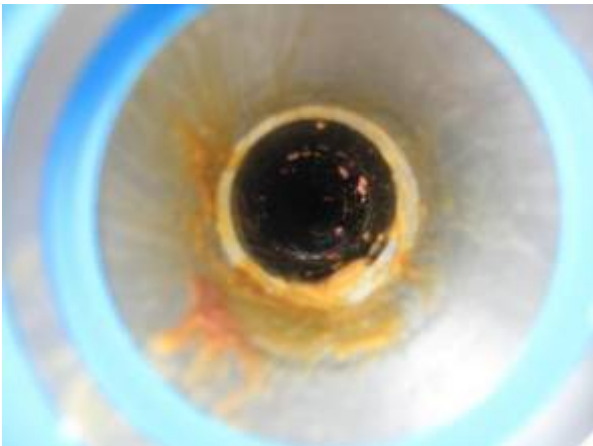
During a rig inspection, grease was found in the hydraulic conduit lines on the rig (figure 1). A hydraulic line box end had grit and an anti-seize material in the inner diameter (figure 2). The auxiliary lines, pins, and boxes did not have any protection installed on them.

Figure 1: This hydraulic line box end has grease in the inner diameter.

The riser joints already onboard the rig should be fully cleaned. The riser joints also need to be protected when transferring them to the riser bay. Protectors should be installed on the pin and in the box ends of the auxiliary lines. Main pin and box end protectors should also be installed. Protectors will aid in minimizing damage and keeping dirt and debris out of the auxiliary and conduit lines. The hydraulic lines especially need to be free of dirt and debris. Dirt and debris from the conduit lines could eventually end up in the BOP control system, which can lead to failures in places like solenoid valves, orifices and filters. This can result in very costly downtime.

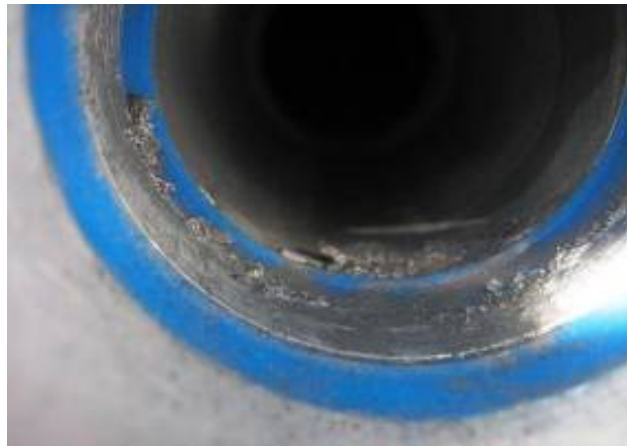
Figure 2: The hydraulic line box end has grit and an anti-seize material in the inner diameter.

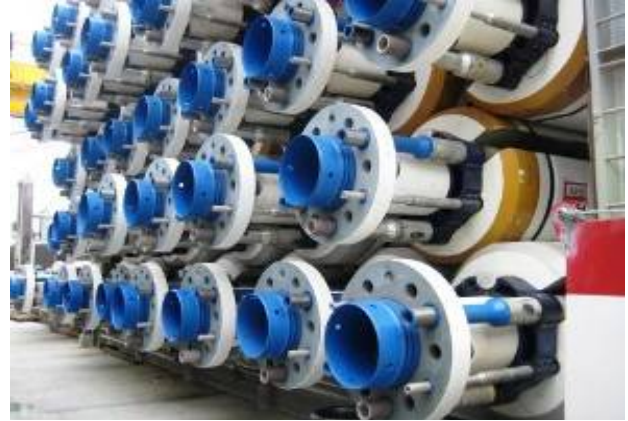
In addition, riser joints that arrived on the rig from ashore had no protectors installed on them. A visual inspection found debris in the auxiliary lines. Also, black blast grit was found in the conduit lines. The riser joints in storage had no pin protectors installed on them (figure 3). One of the risers was made up with the slip joint and placed in the spider. The riser was flushed with about 1¼ times the volume of the riser with seawater by pumping through the top drive. A good bit of debris was seen being flushed from the riser.

Figure 3: The risers have no protectors installed.

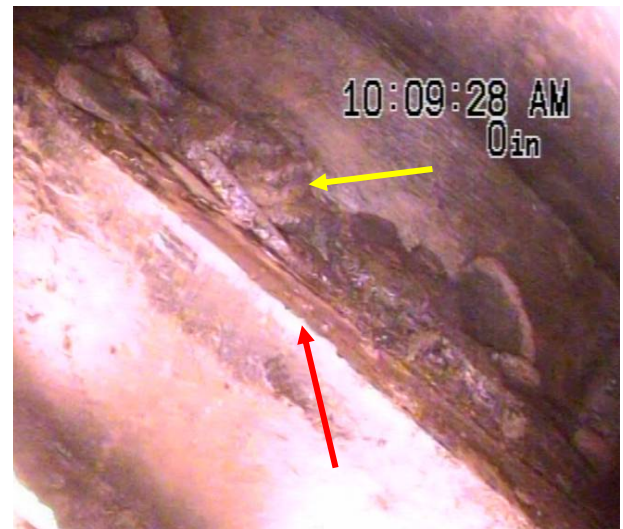
A borescope was used to visually inspect the inside of the BOP (blowout preventer). Debris was found in the blind and casing shear cavities. In figure 4, the yellow arrow points to debris on the blind shear ram's lower blade. This photo was cut from the borescope video during inspection. The blind and casing shear doors will need to be opened to find and remove the debris. When the doors were opened, caked blasting sand was found. There was caked blasting sand seen in other places inside the BOP as well. Therefore, all the bonnet doors were opened on the BOP to clean out all the debris inside the cavities (figures 5 and 6).

Figure 4: Debris on the blind shear lower blade.

The scale in the BOP probably would not have been present if this was a drilling well. In this case, the BOP was new and had a lot of grease and scale.

Keeping the auxiliary lines, hydraulic conduit lines, and risers covered and clean will help keep debris out of the rams. If there is debris in the rams, downtime could occur. The rams would have to be opened to remove the debris. A borescope can be used to inspect the rams for debris and corrosion before sending the BOP stack down-hole.

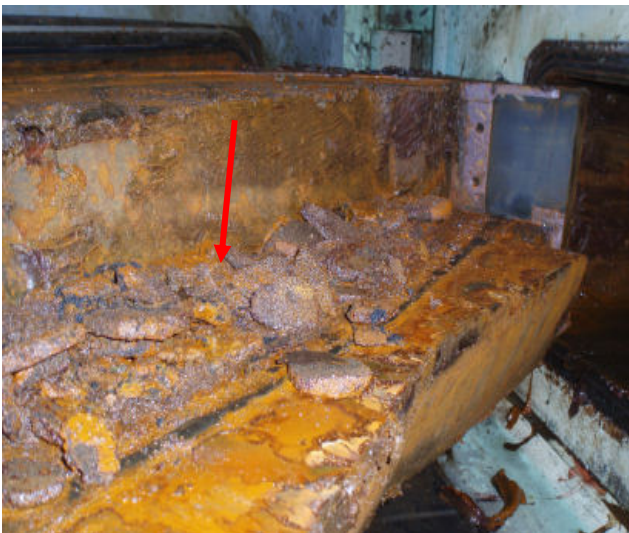
Figure 5: Red arrow shows caked blasting sand on the starboard blind shear ram block.

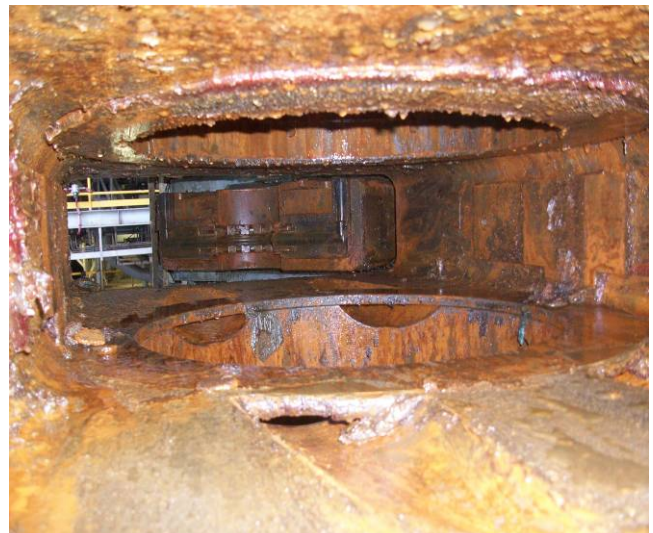
Figure 6: The red arrows show caked debris on the pipe ram's cavity.

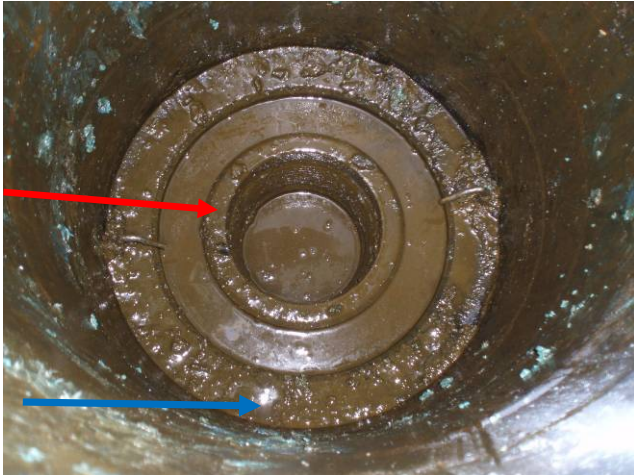
There were also problems screwing into the test stump. Debris inside the stump required the BOP to be taken from the stored position and put on the transporter lift to clean the stump. Figure 7 shows the inside of the test stump where the crossover makes up. Figure 8 shows this body, normally screwed in from the bottom of the stump, removed from the stump. The red and blue arrows in figures 7 and 8 are pointing to the same areas on the stump body. The red arrows in figures 7 and 8 point to where the crossover screws into the stump. The guide funnel, indicated by the yellow arrow in figure 8, was removed to clean the stump.

Figure 7: The inside of the test stump.

It is recommended to wash the bore of the BOP with a wash tool after pulling, and before setting it in the setback area for maintenance. This procedure would wash out annular and ram cavities as well. It would also help prevent lost time cleaning out the test stump. Just be careful to follow manufacturer's recommendations on pressure to the wash tool, to avoid damaging BOP rubber and seals.

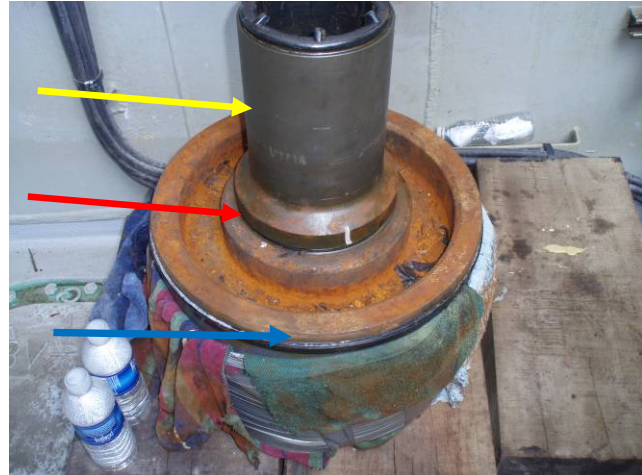
Figure 8: The body removed from the test stump.
